U.S. Department  
of Transportation

National Highway  
Traffic Safety  
Administration

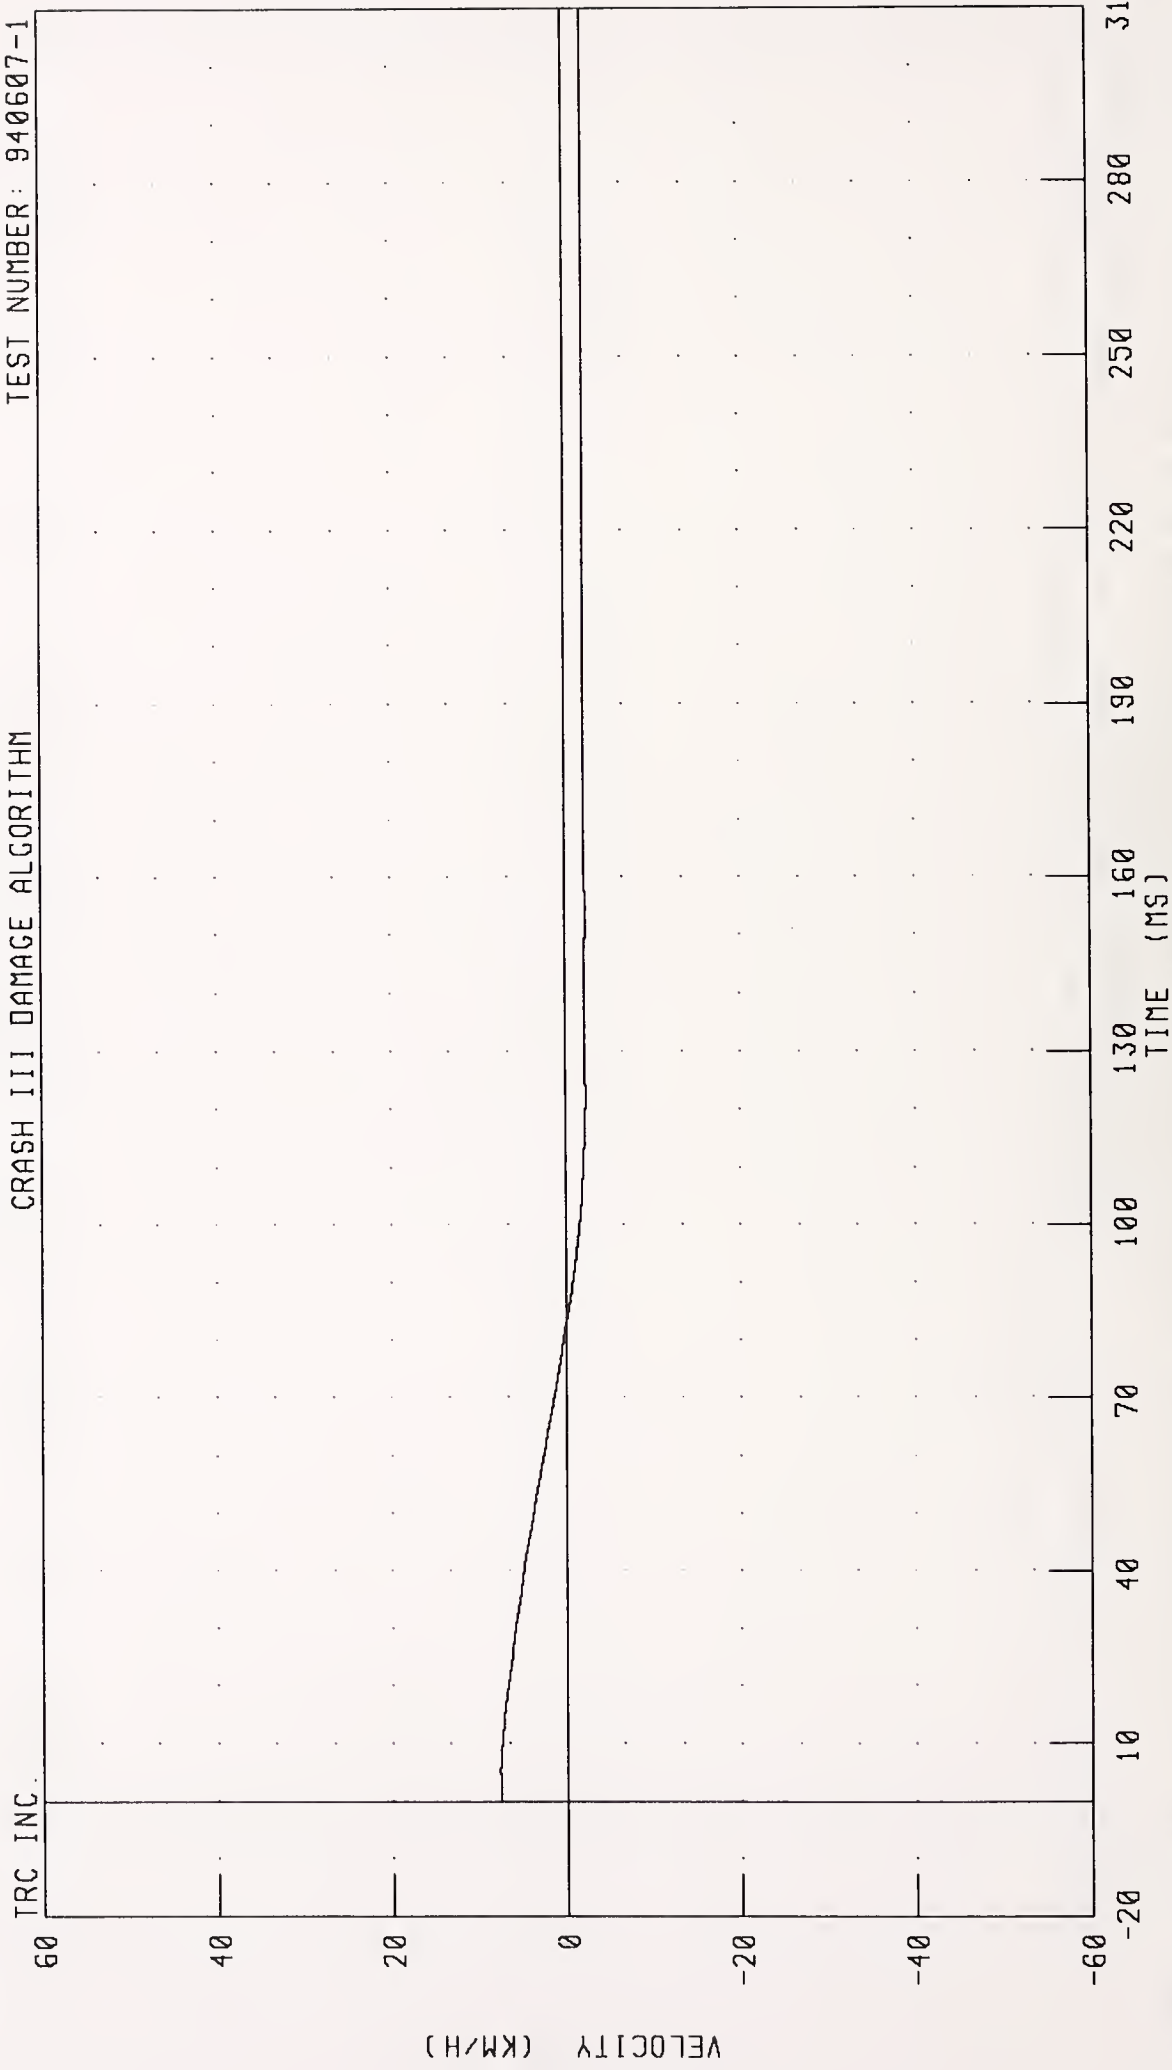
CHANNEL: LRSXV1 FILTER: CH. CLASS 180 PEAK DATA: 7.72 KM/H @ 5.28 MS; -2.31 KM/H @ 155.04 MS

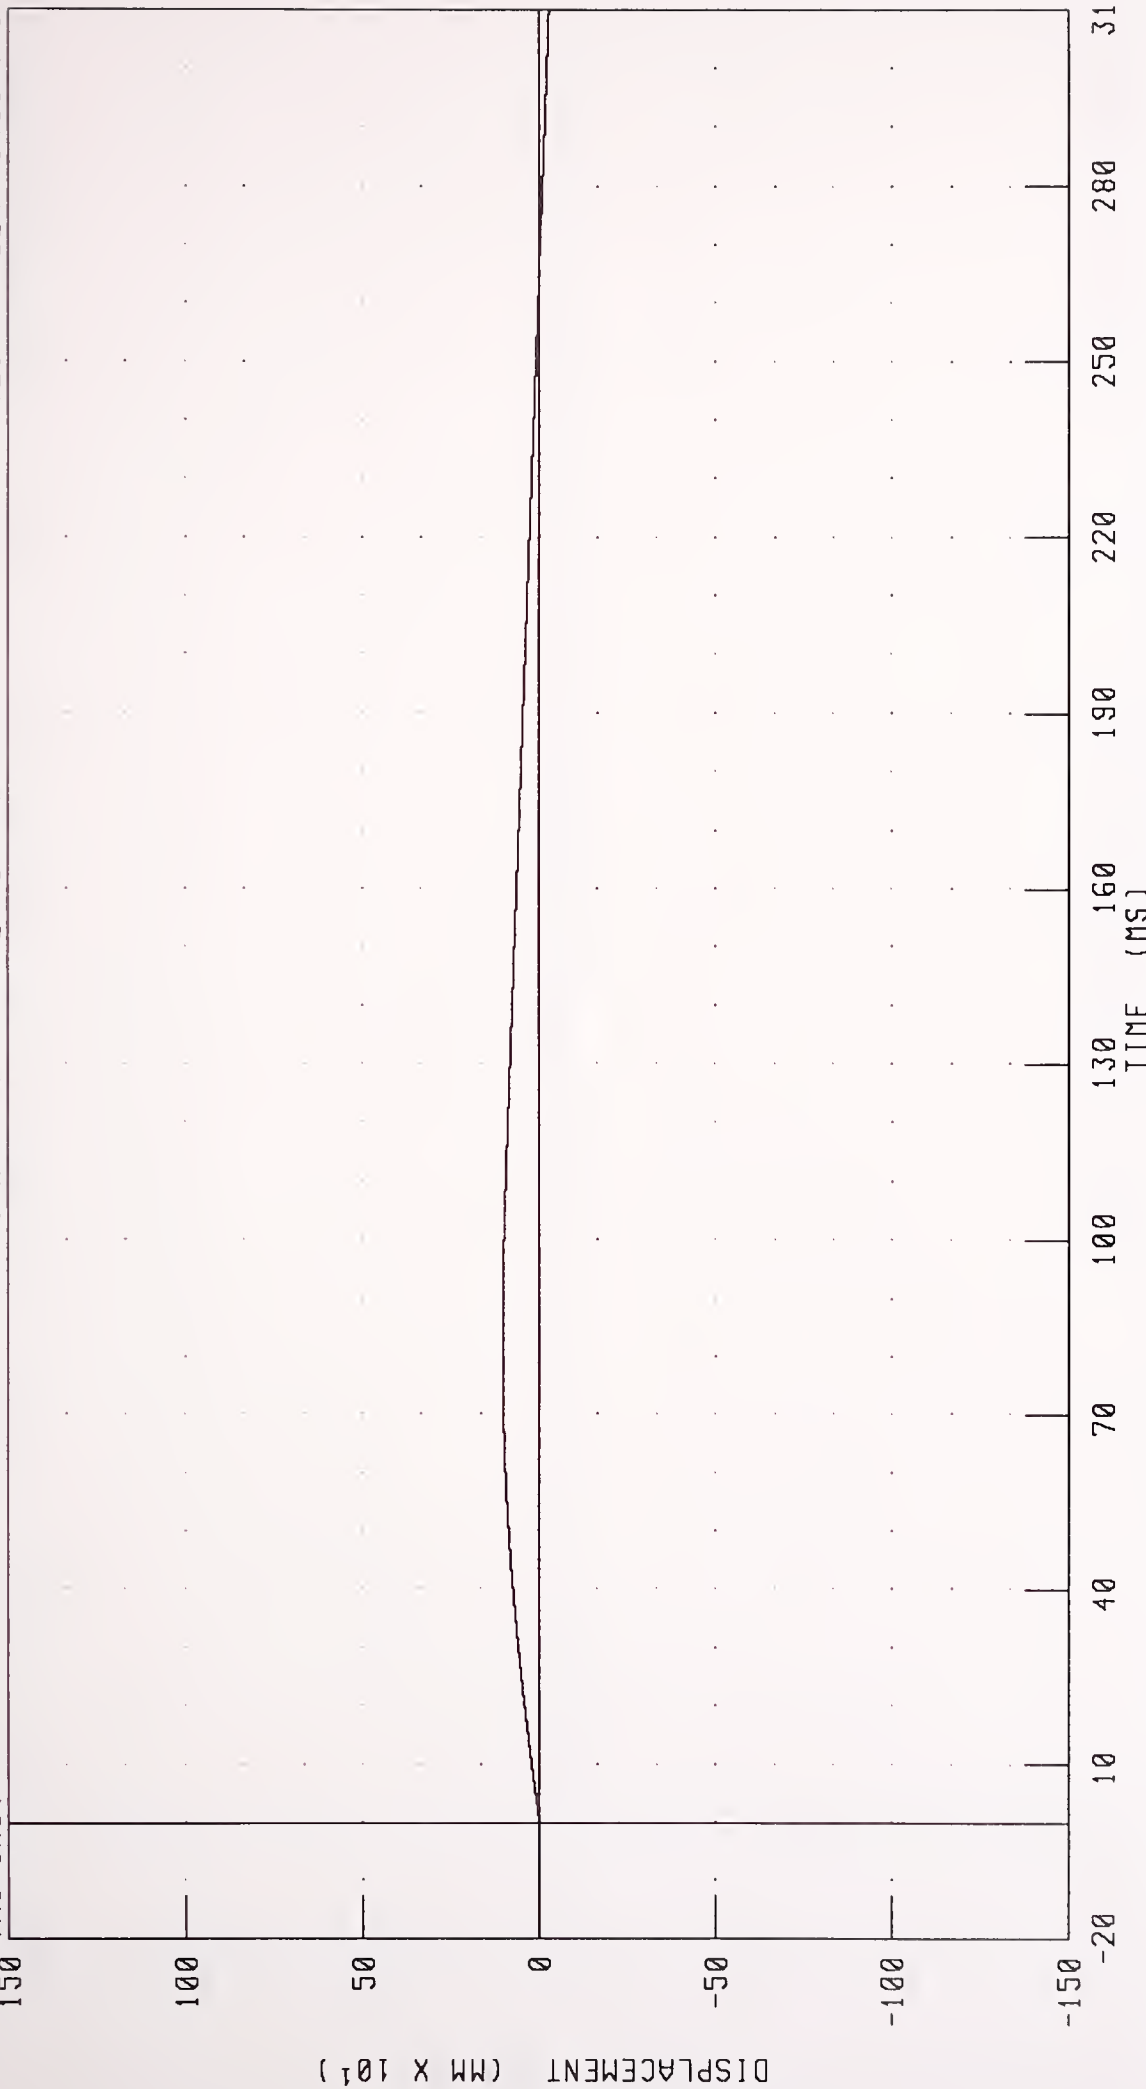
CHANNEL: LRSXD1 FILTER: CH. CLASS 180 PEAK DATA: 103.81 MM @ 83.04 MS; -27.84 MM @ 310.00 MS

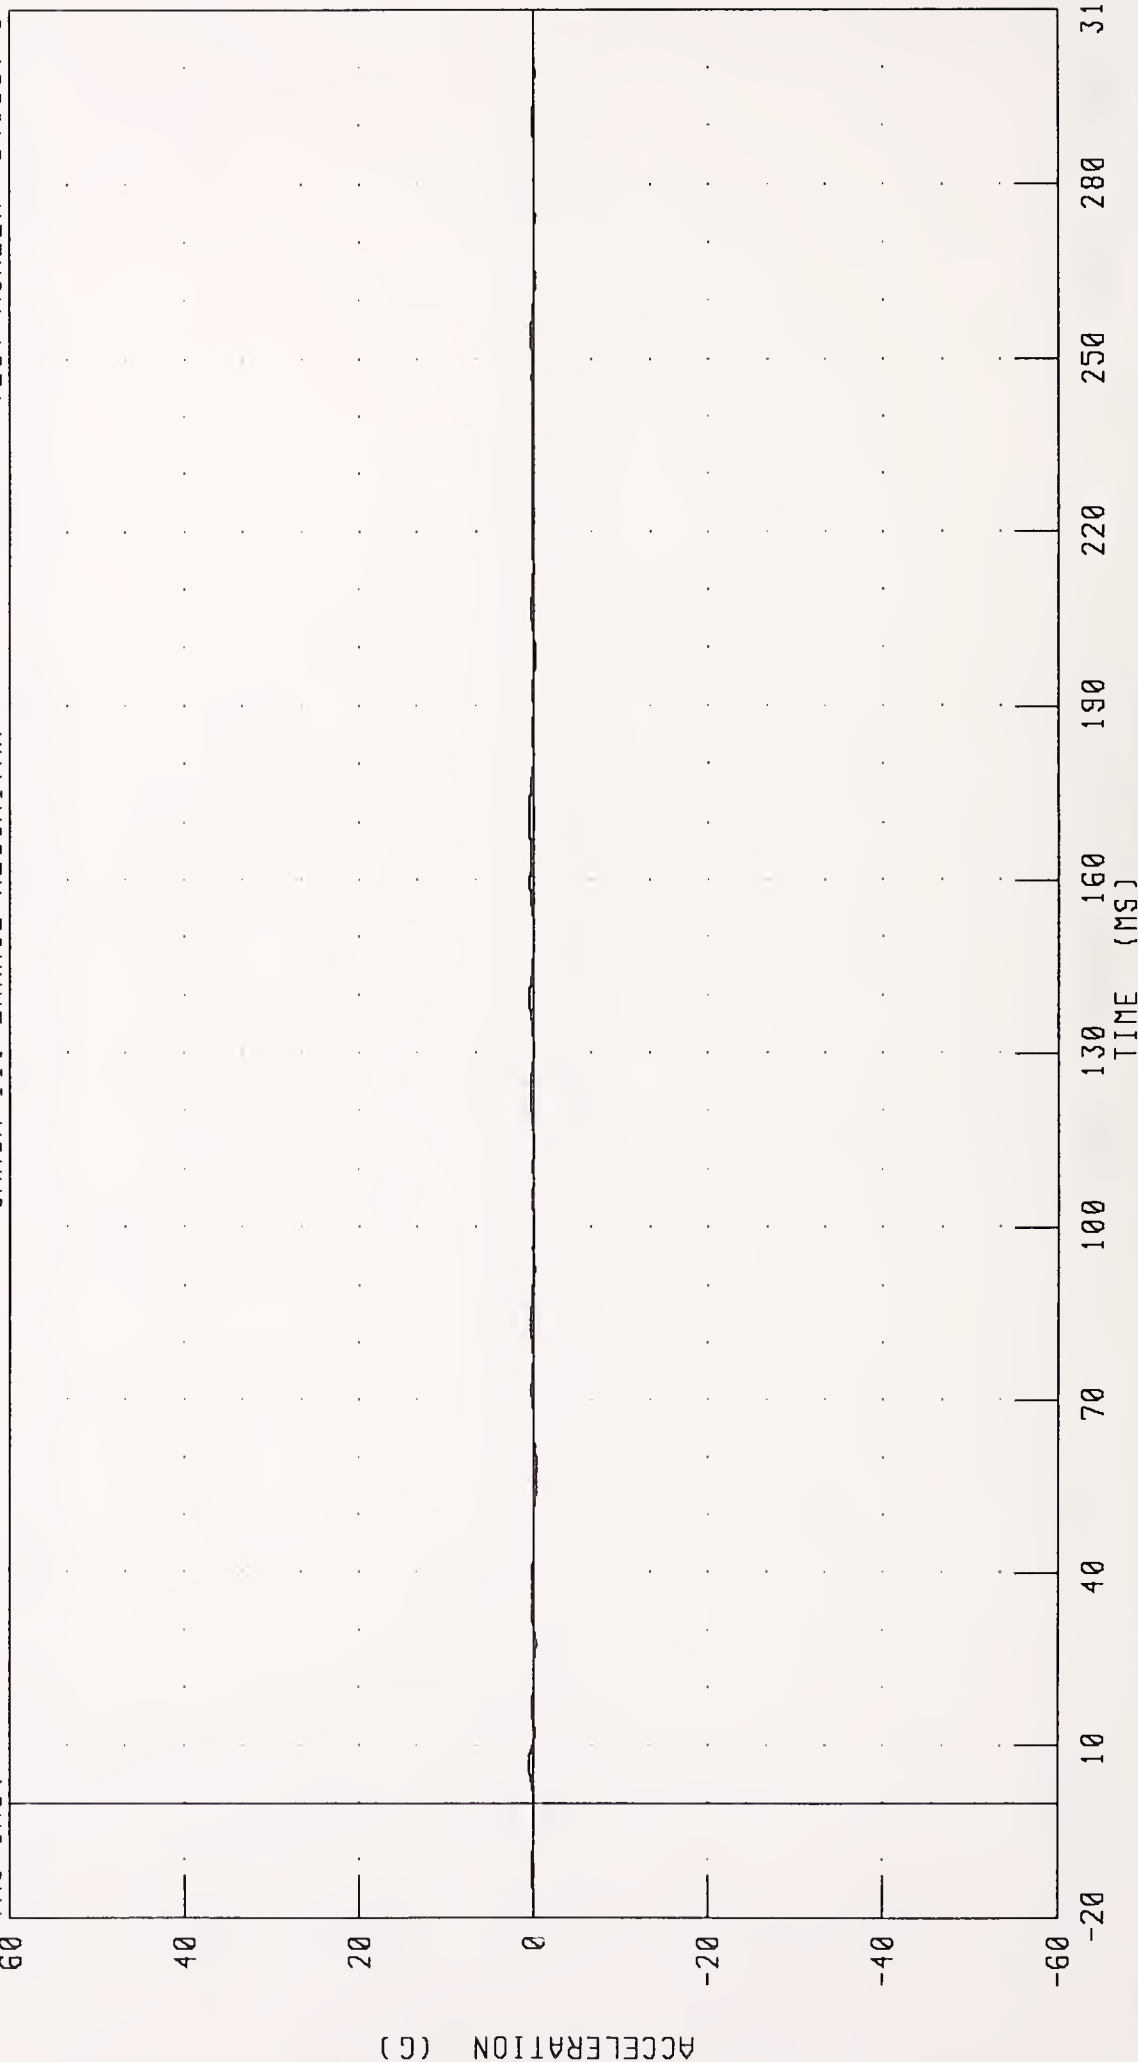
CHANNEL: LRSYG1 FILTER: CH. CLASS 60

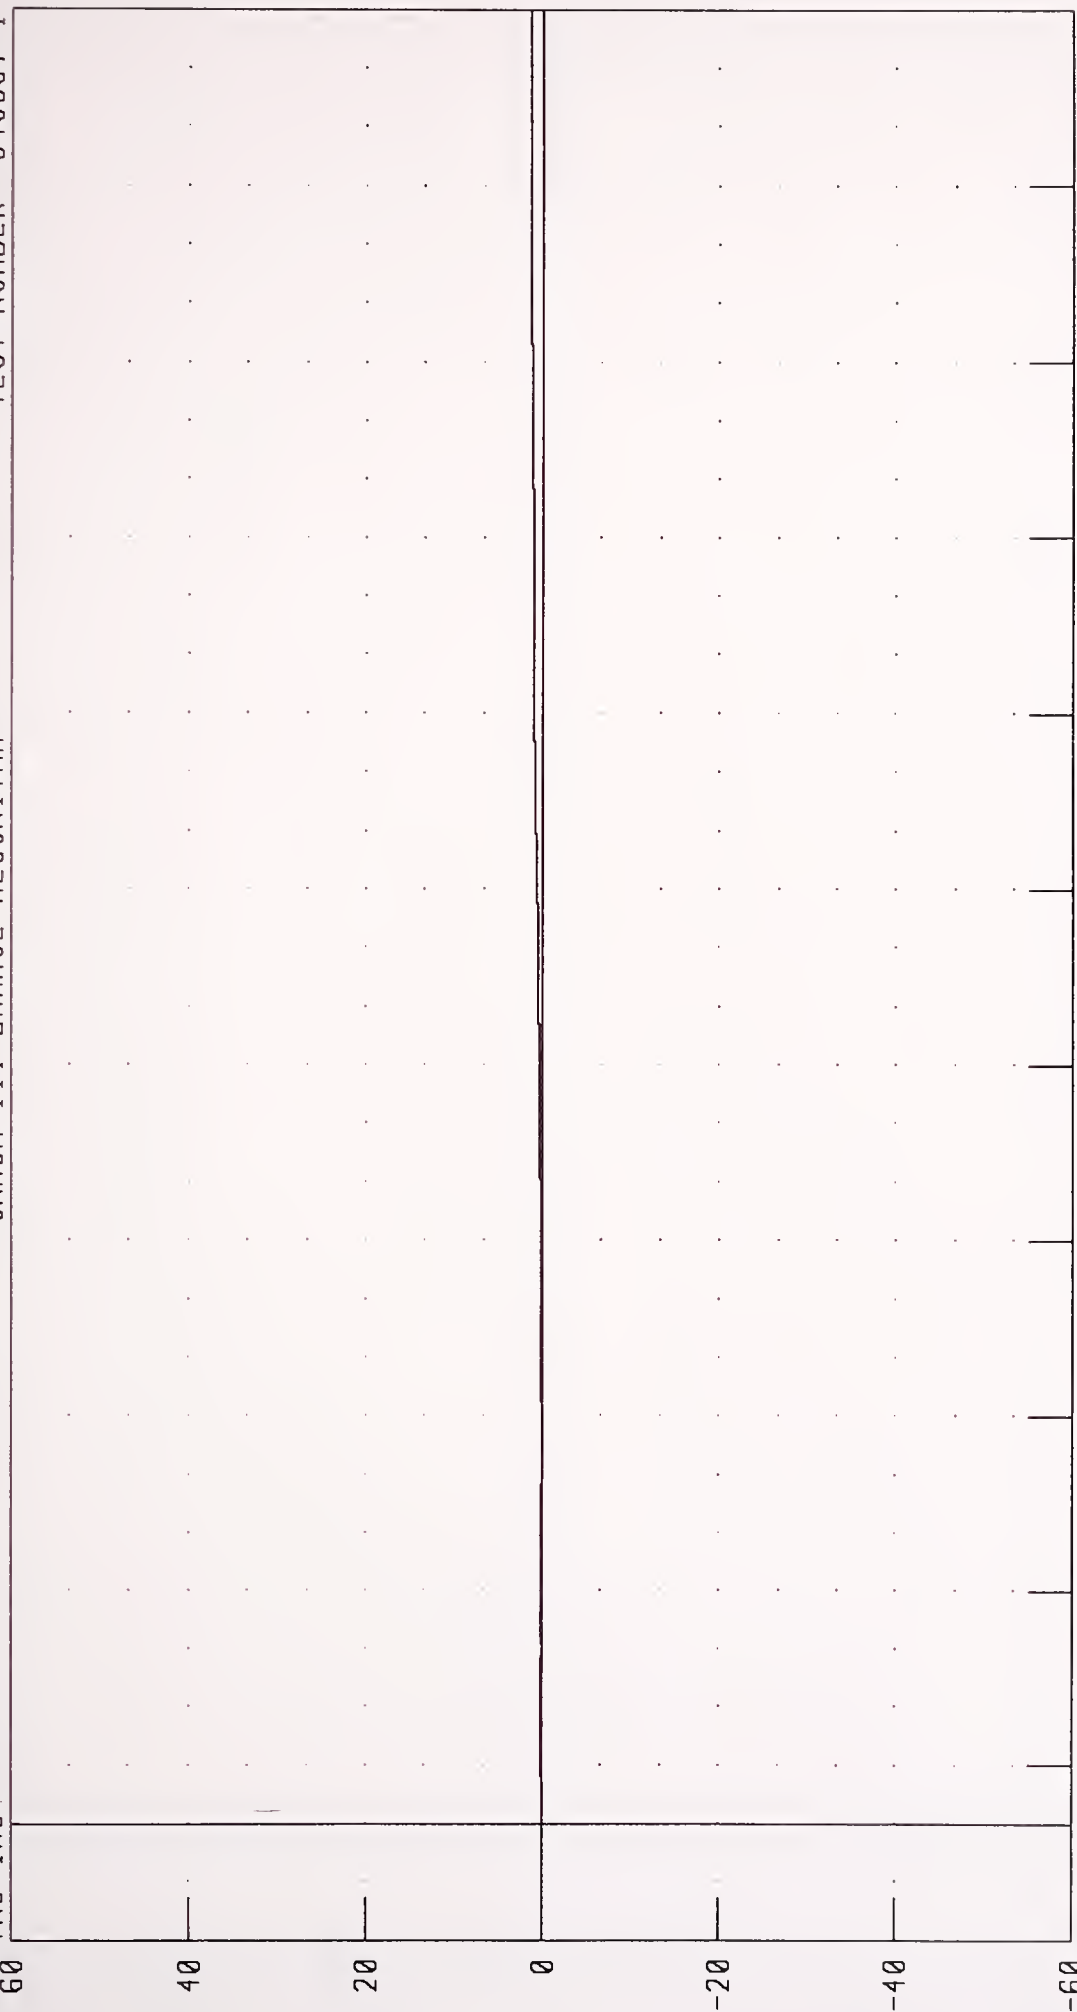
CHANNEL: LRSYV1 FILTER: CH. CLASS 180 PEAK DATA: 1.34 KM/H @ 259.60 MS; 0.00 KM/H @ 0.00 MS

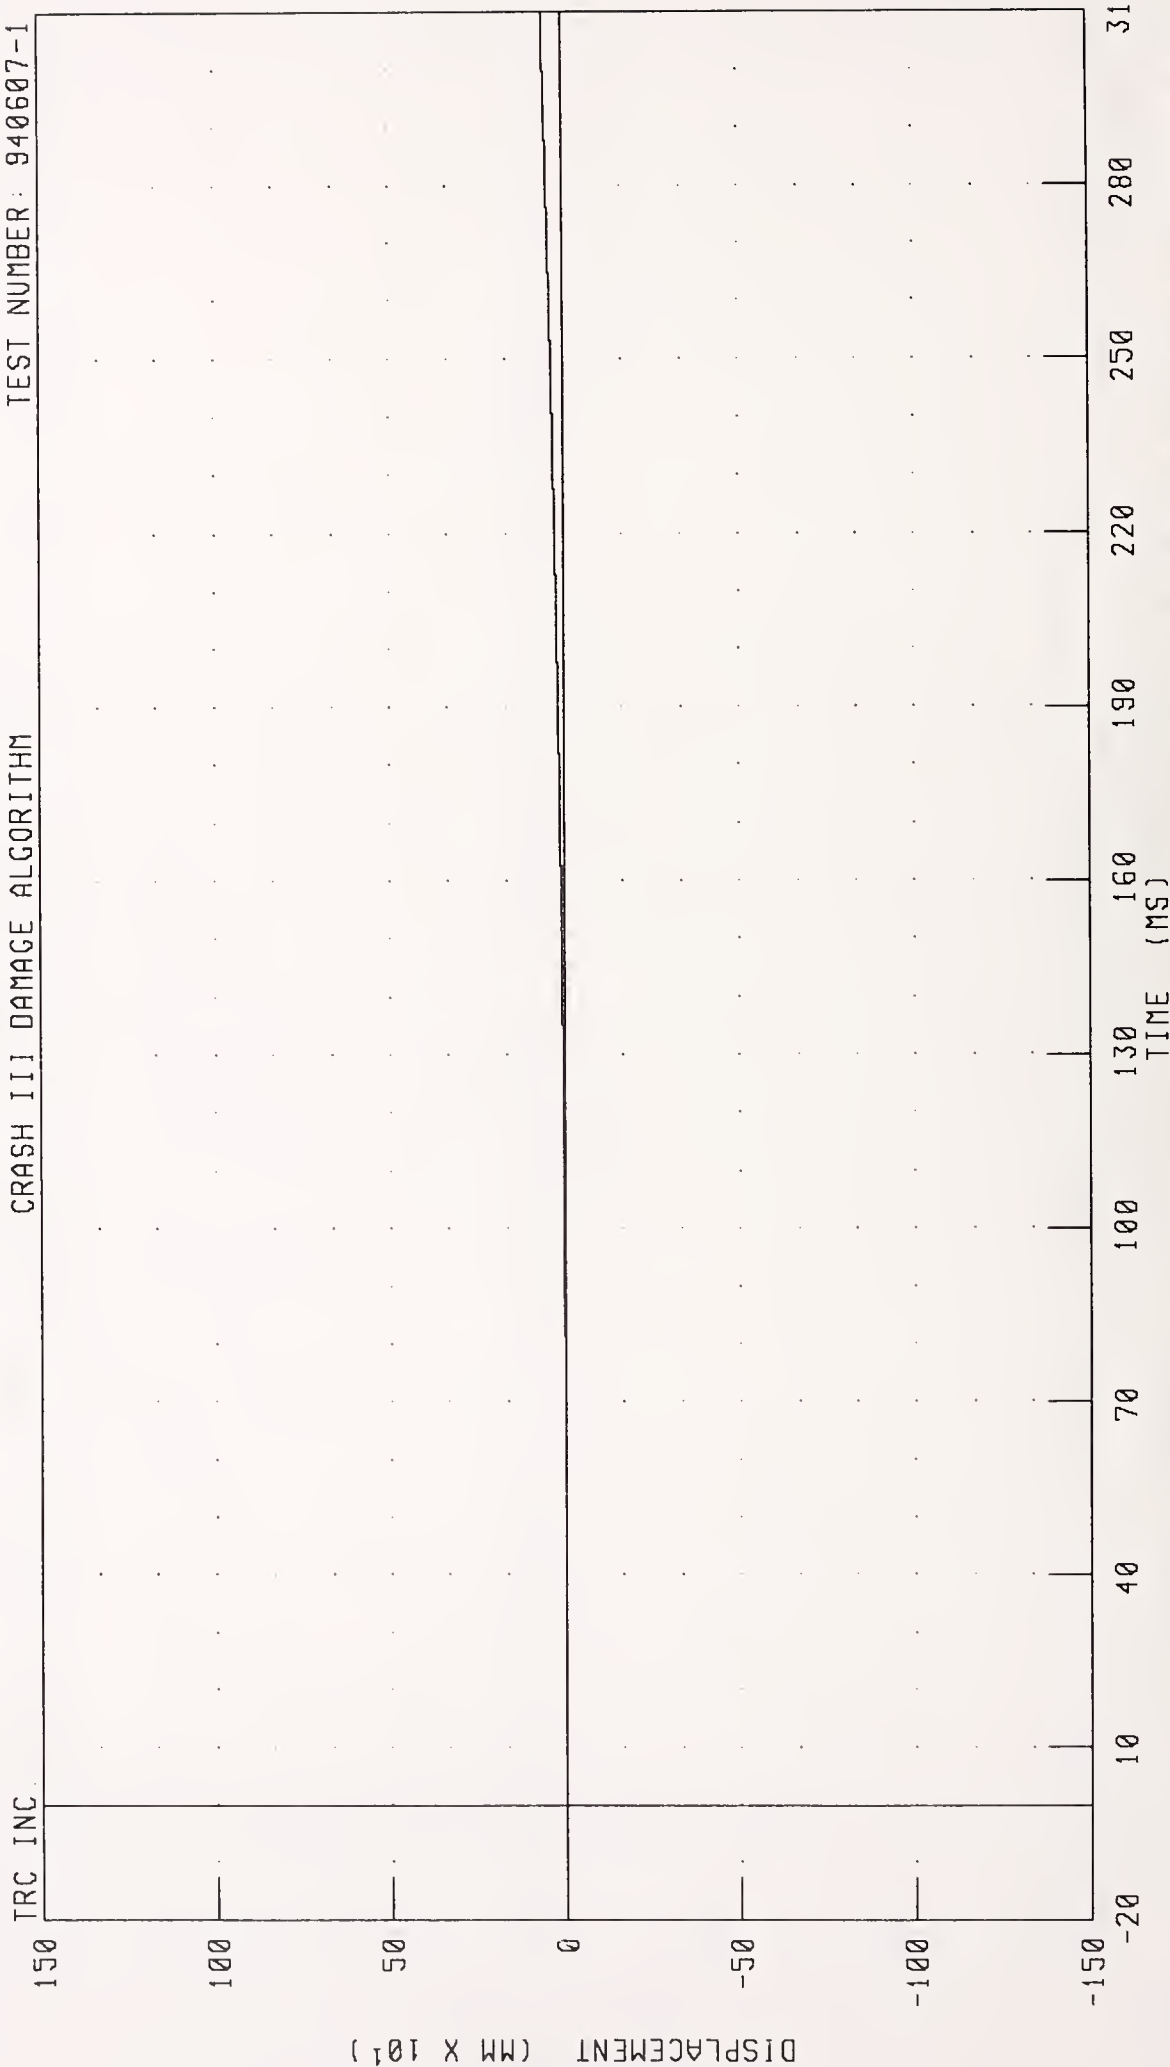
CHANNEL: LRSYD1 FILTER: CH. CLASS 180 PEAK DATA: 56.99 MM @ 310.00 MS; 0.00 MM @ 0.00 MS

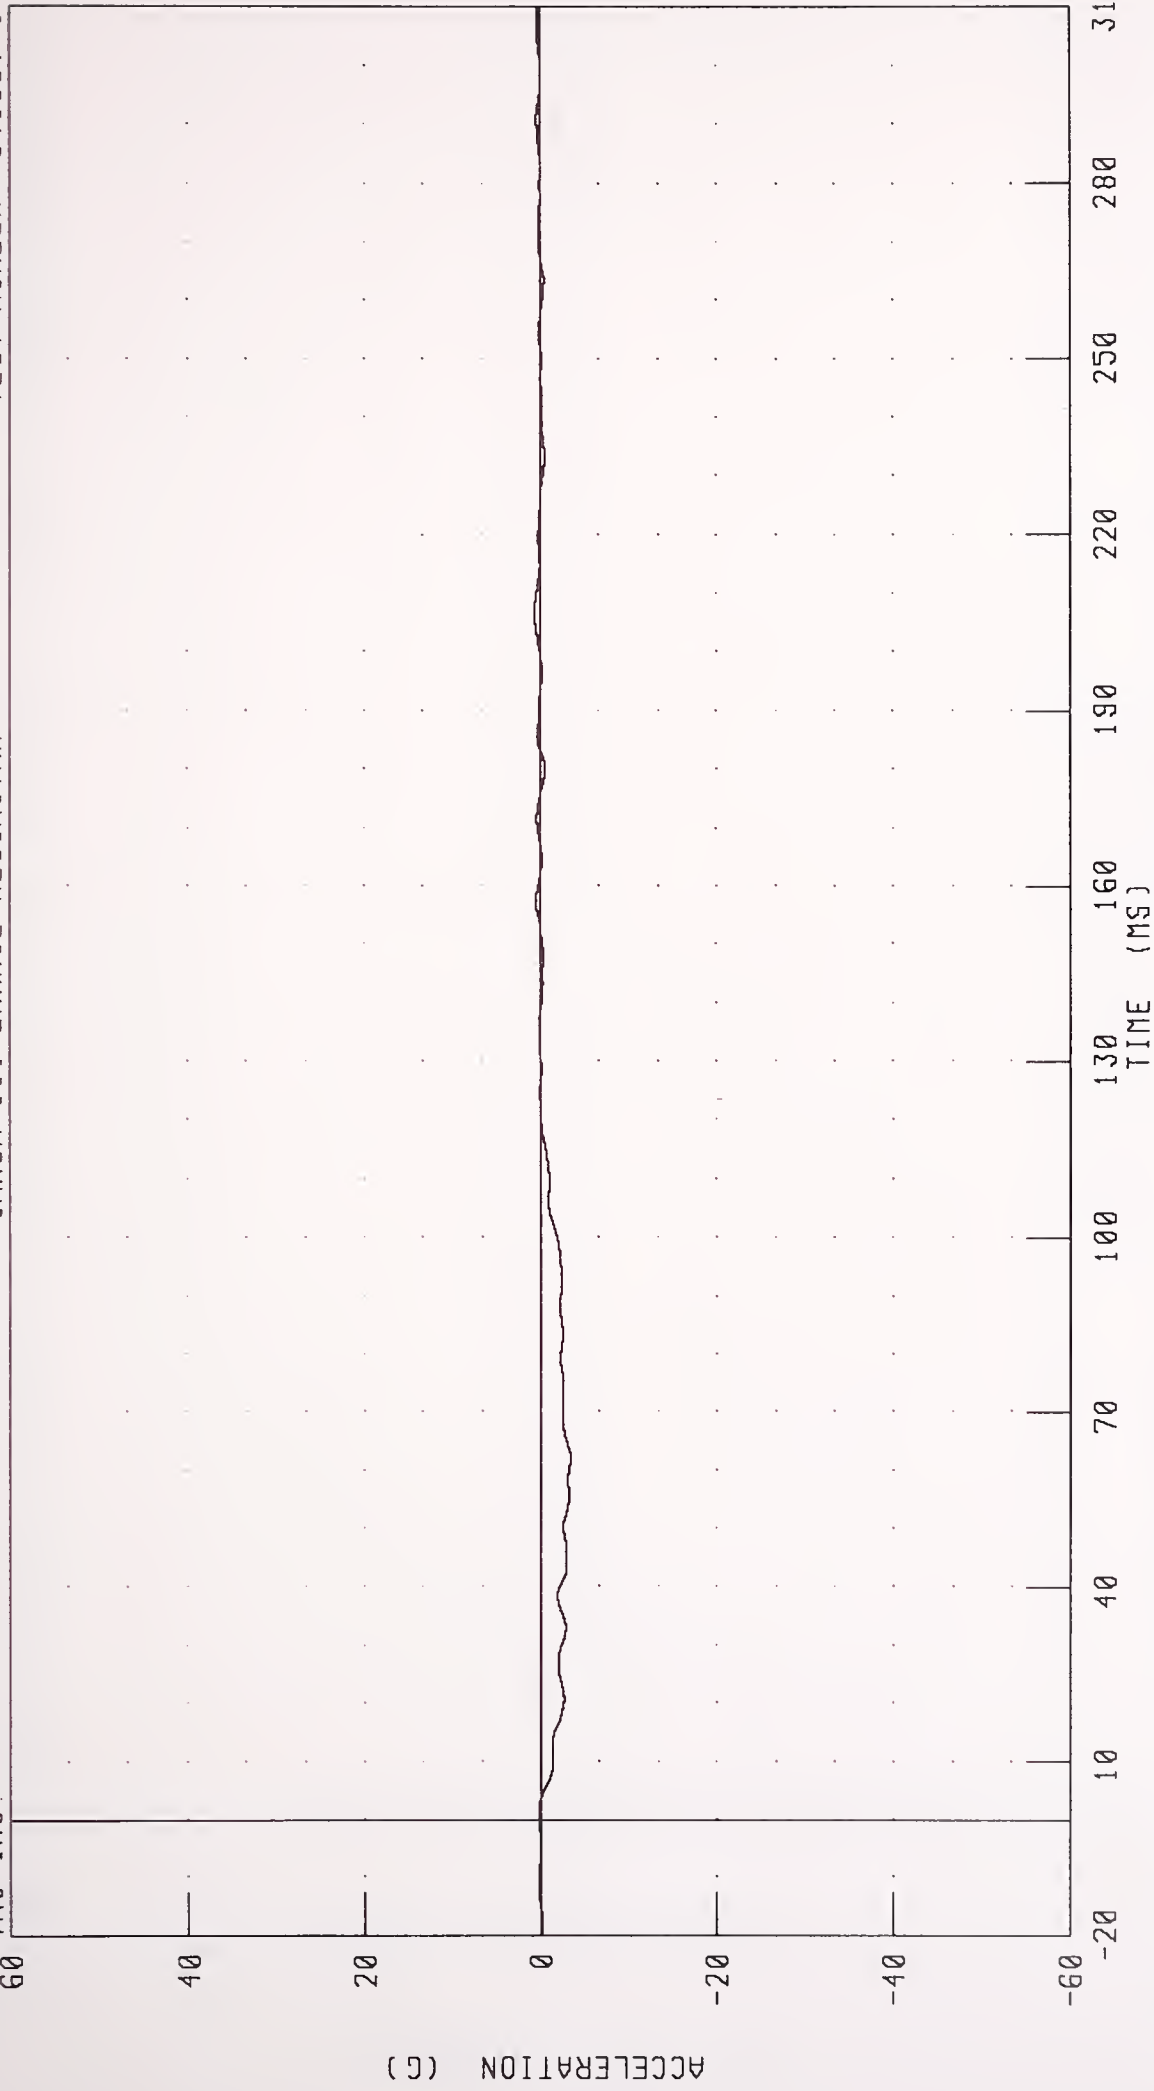
CHANNEL: RRSXG1 FILTER: CH. CLASS 60

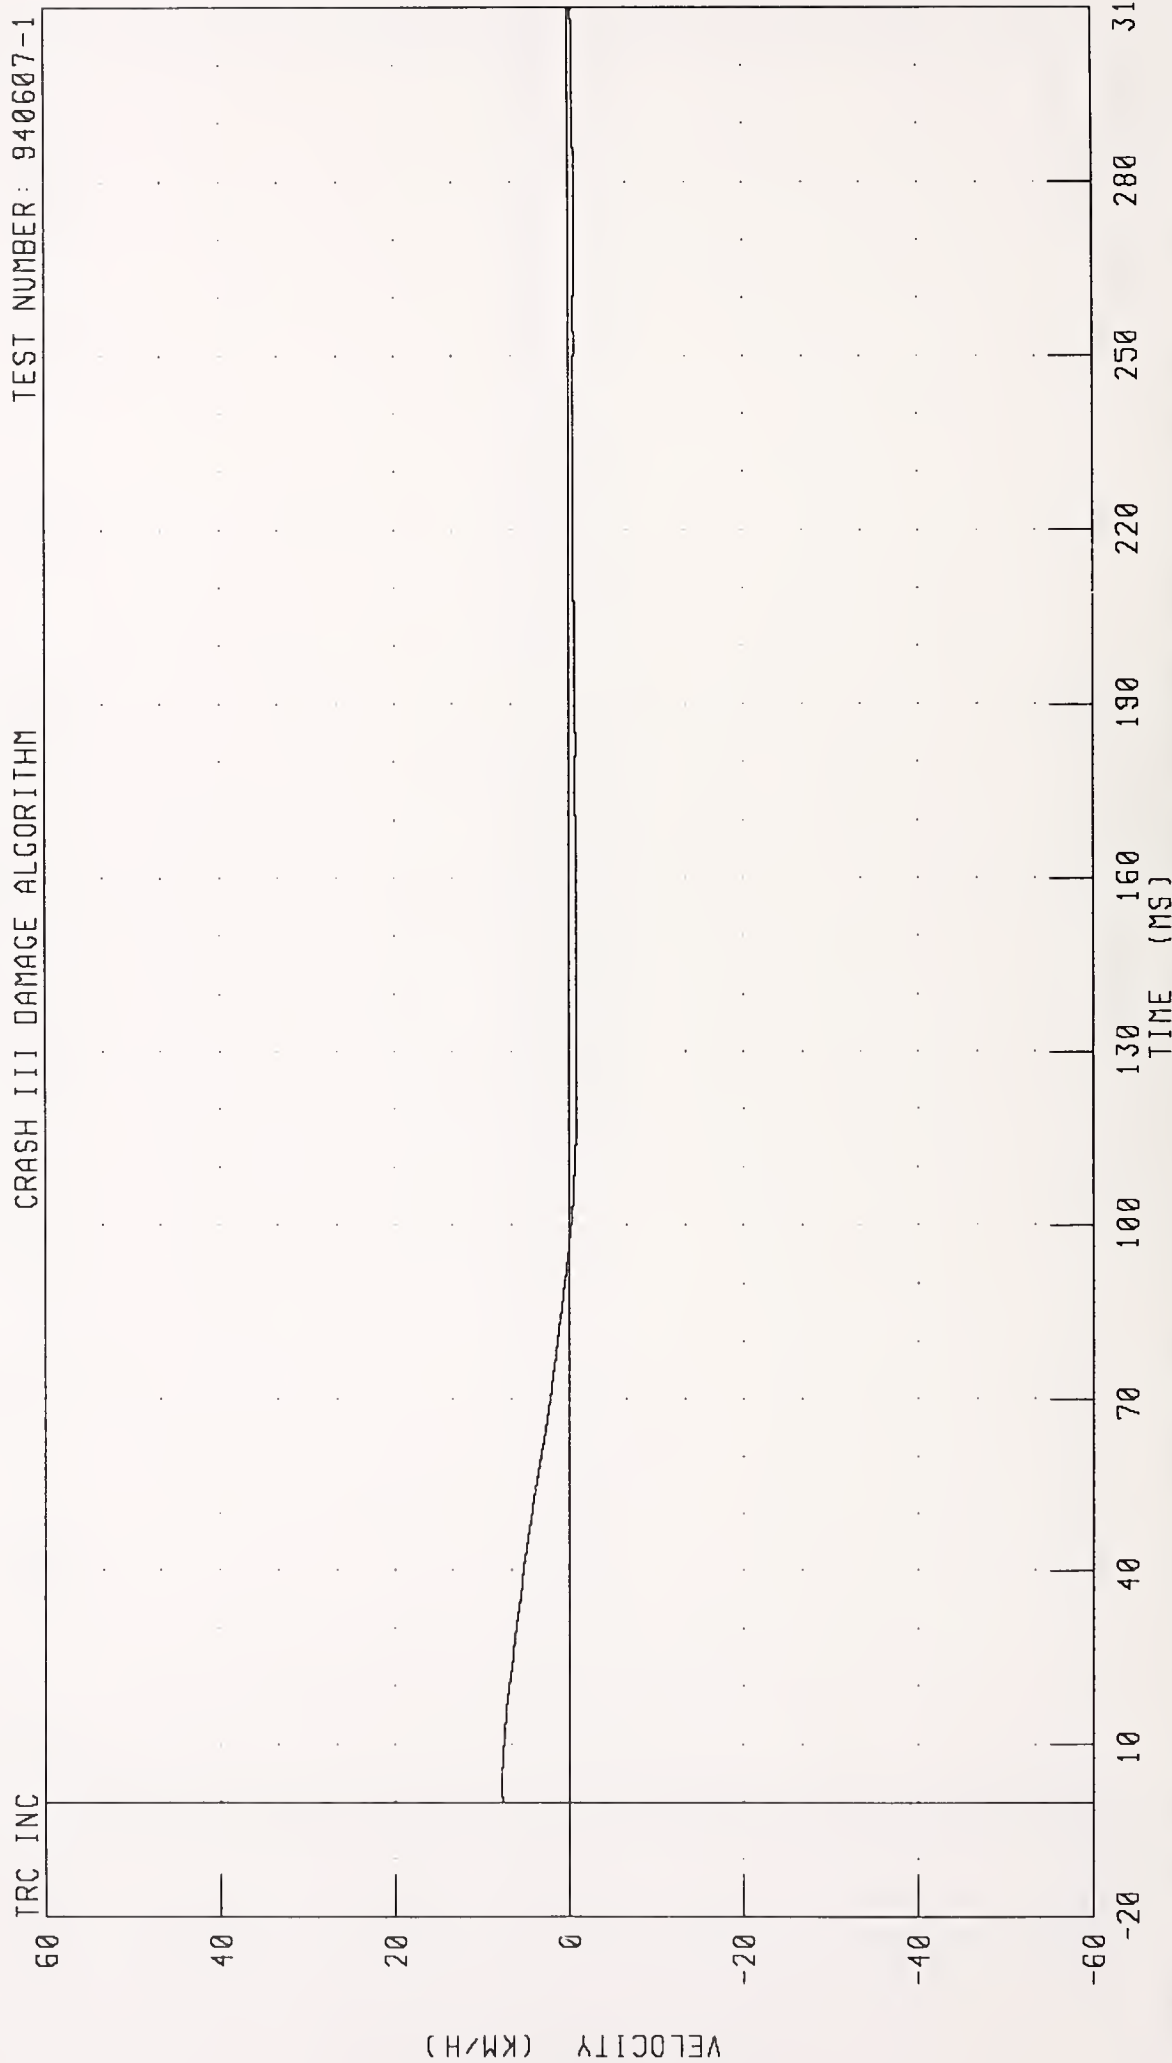
CHANNEL: RRSXV1 FILTER: CH. CLASS 180 PEAK DATA: 7.74 KM/H @ 4.56 MS, -0.86 KM/H @ 154.88 MS

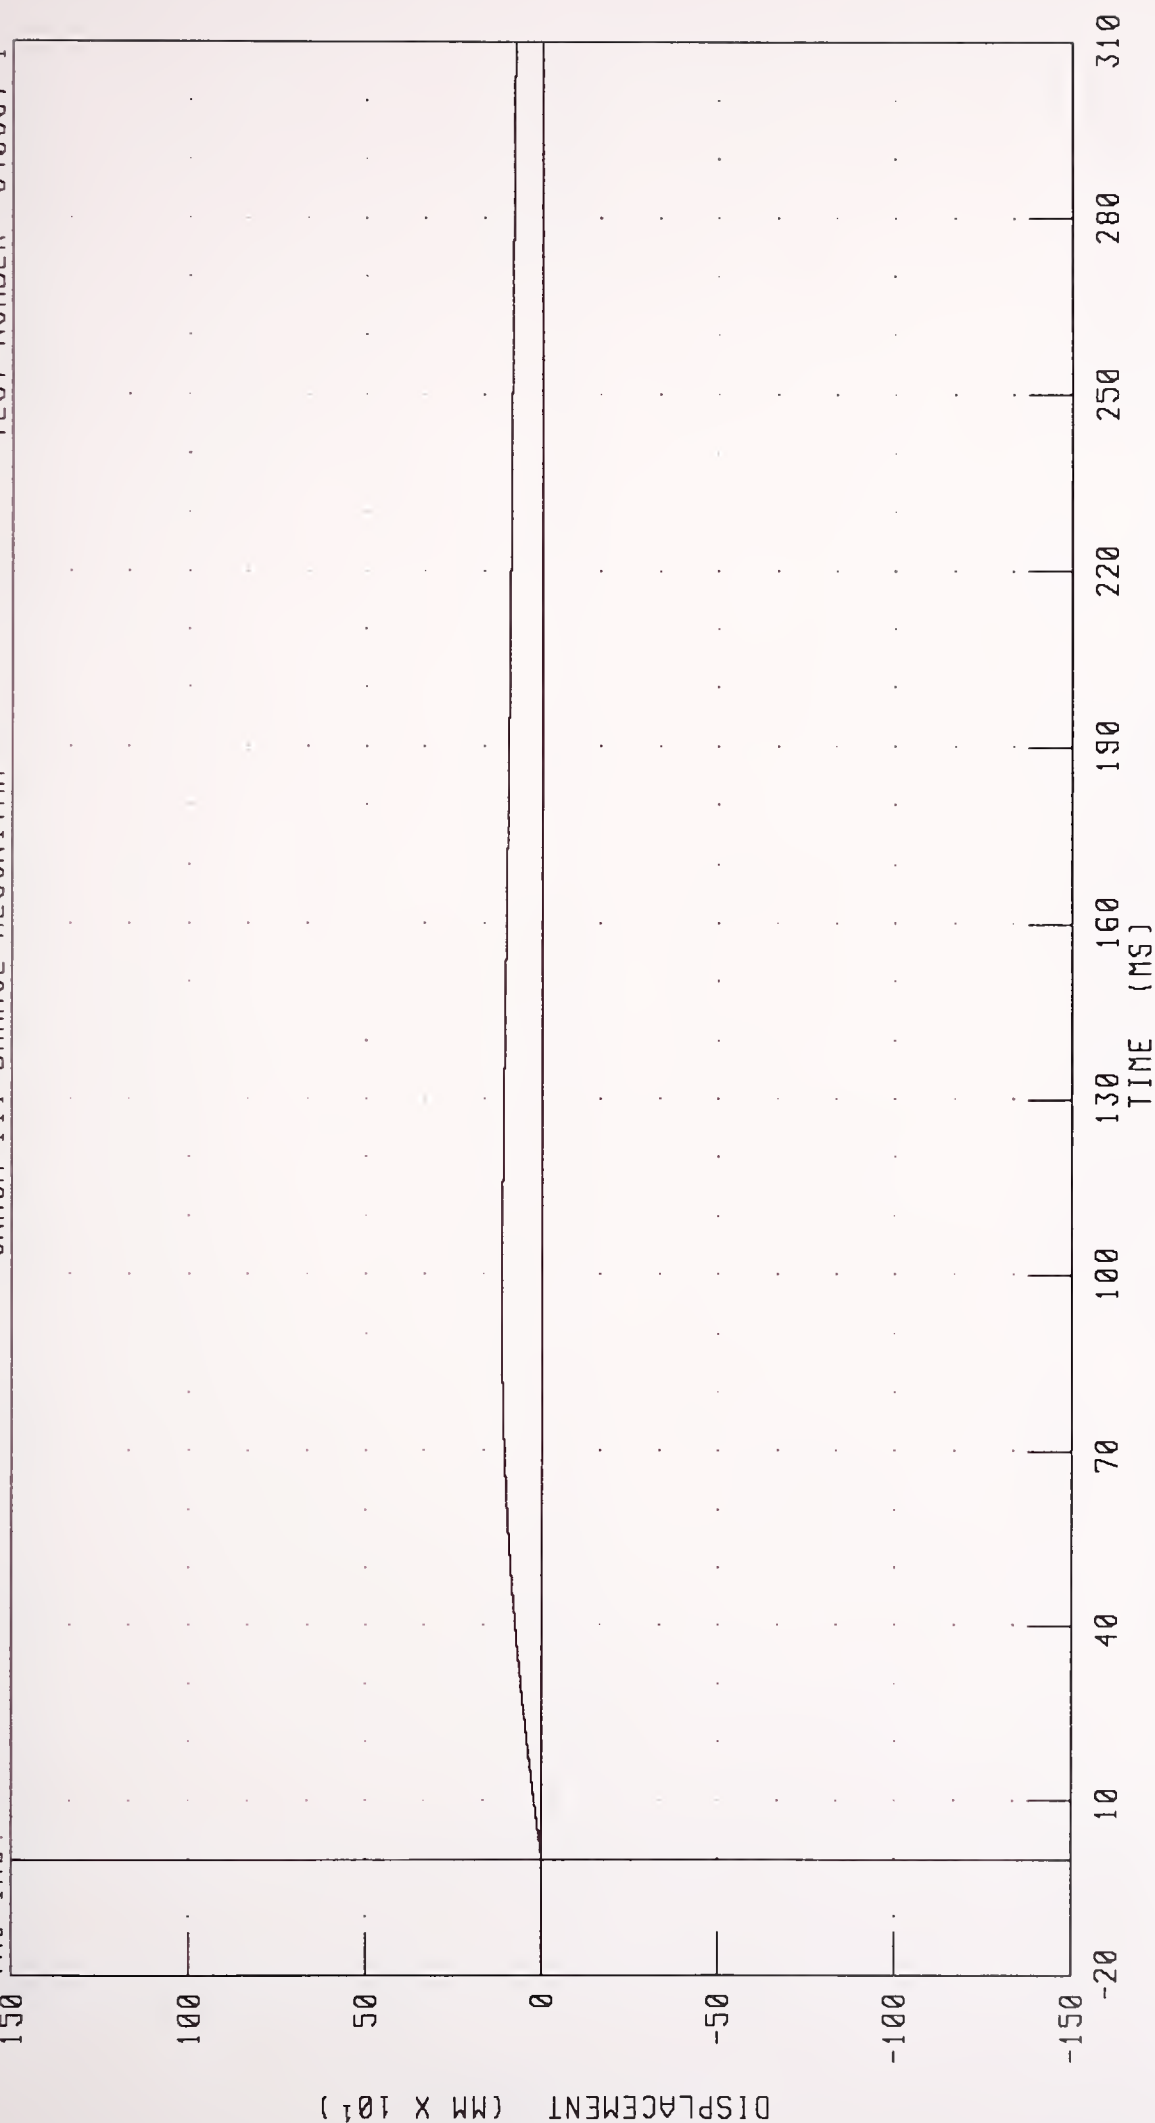
CHANNEL: RRSXD1 FILTER: CH. CLASS 180

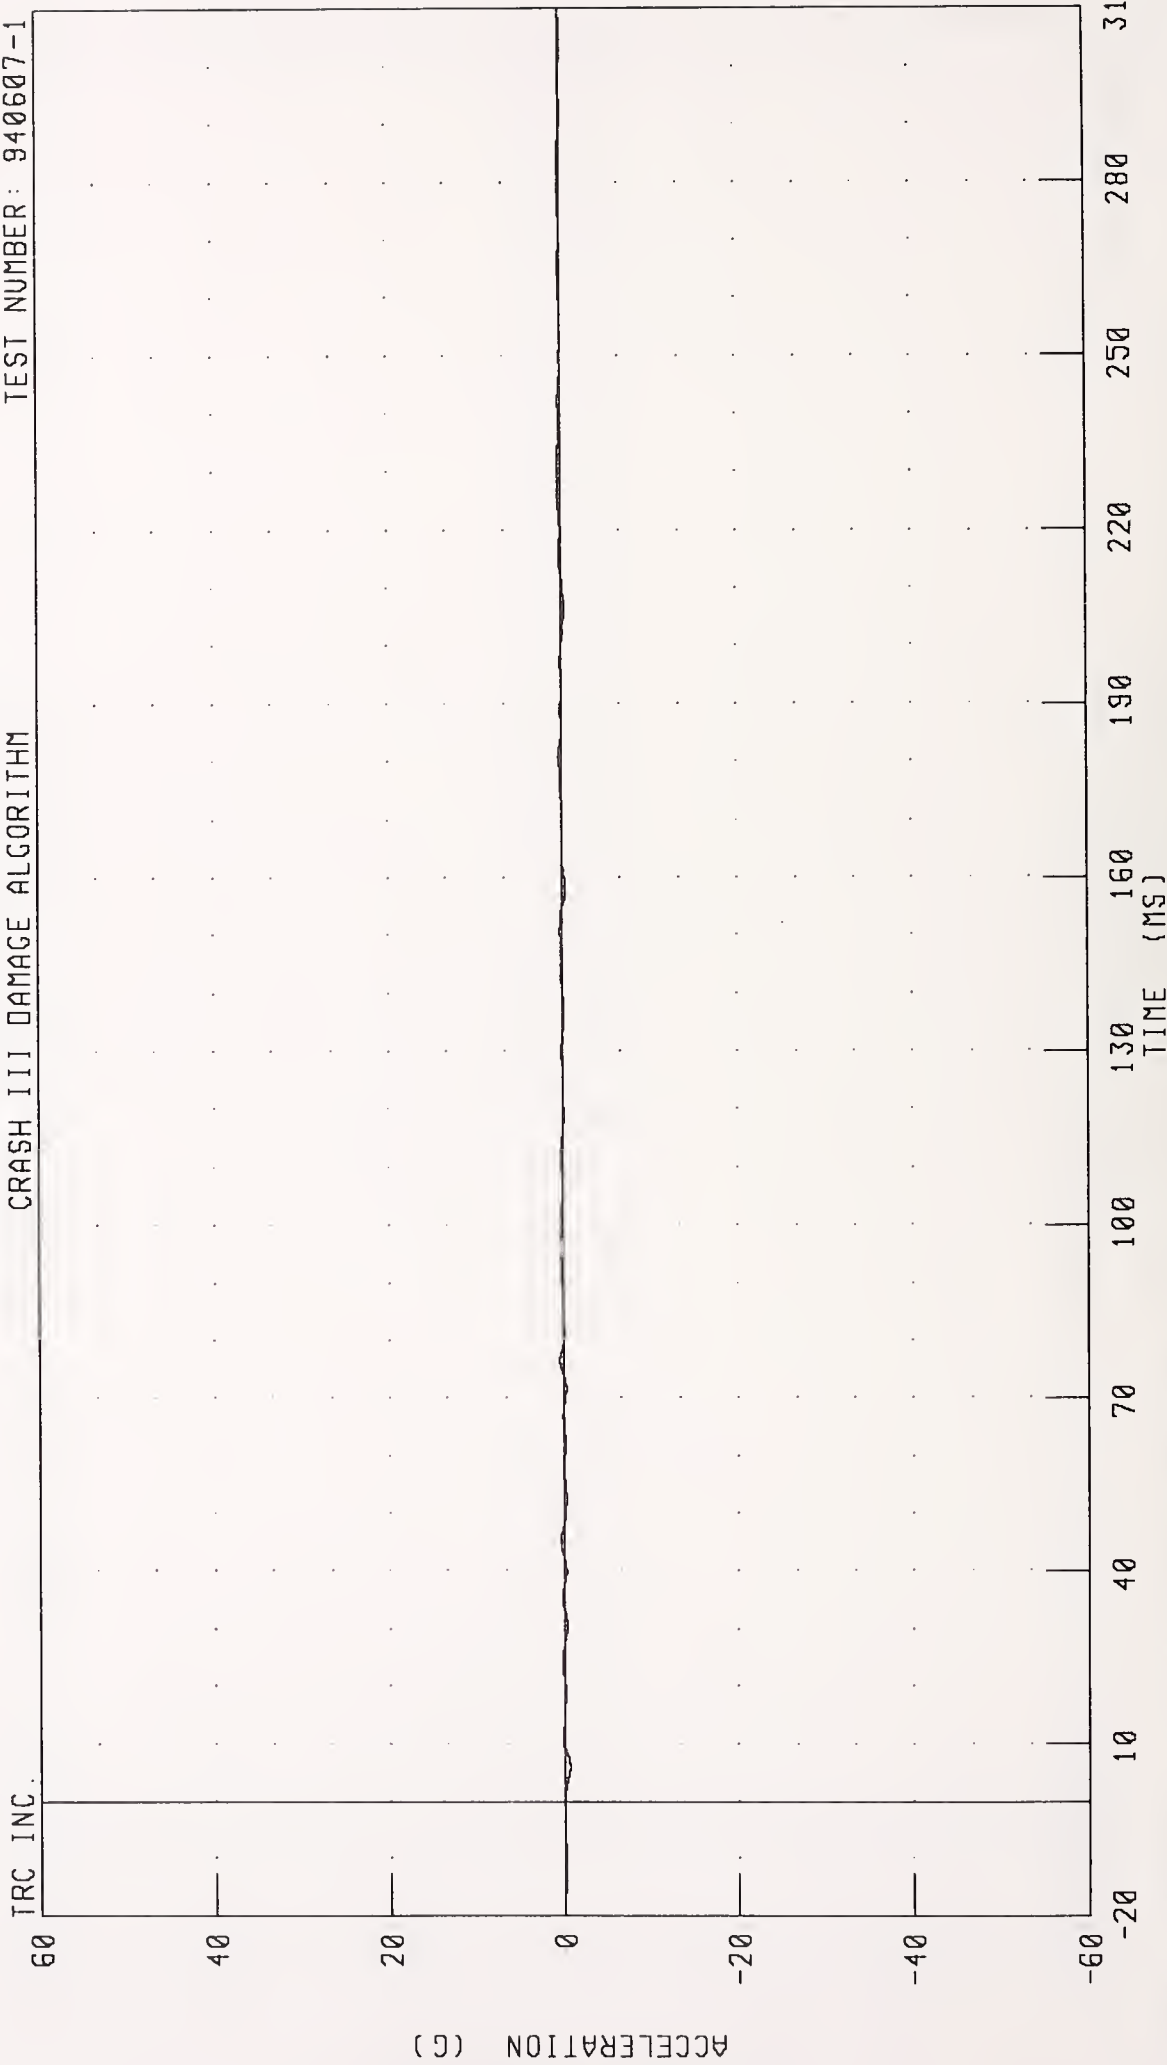
CHANNEL: RRSYG1 FILTER: CH. CLASS 60
